Section 1  
A5 Western Transport Corridor  
Northern Ireland

geophysical survey

report 2746, volume III  
January 2012

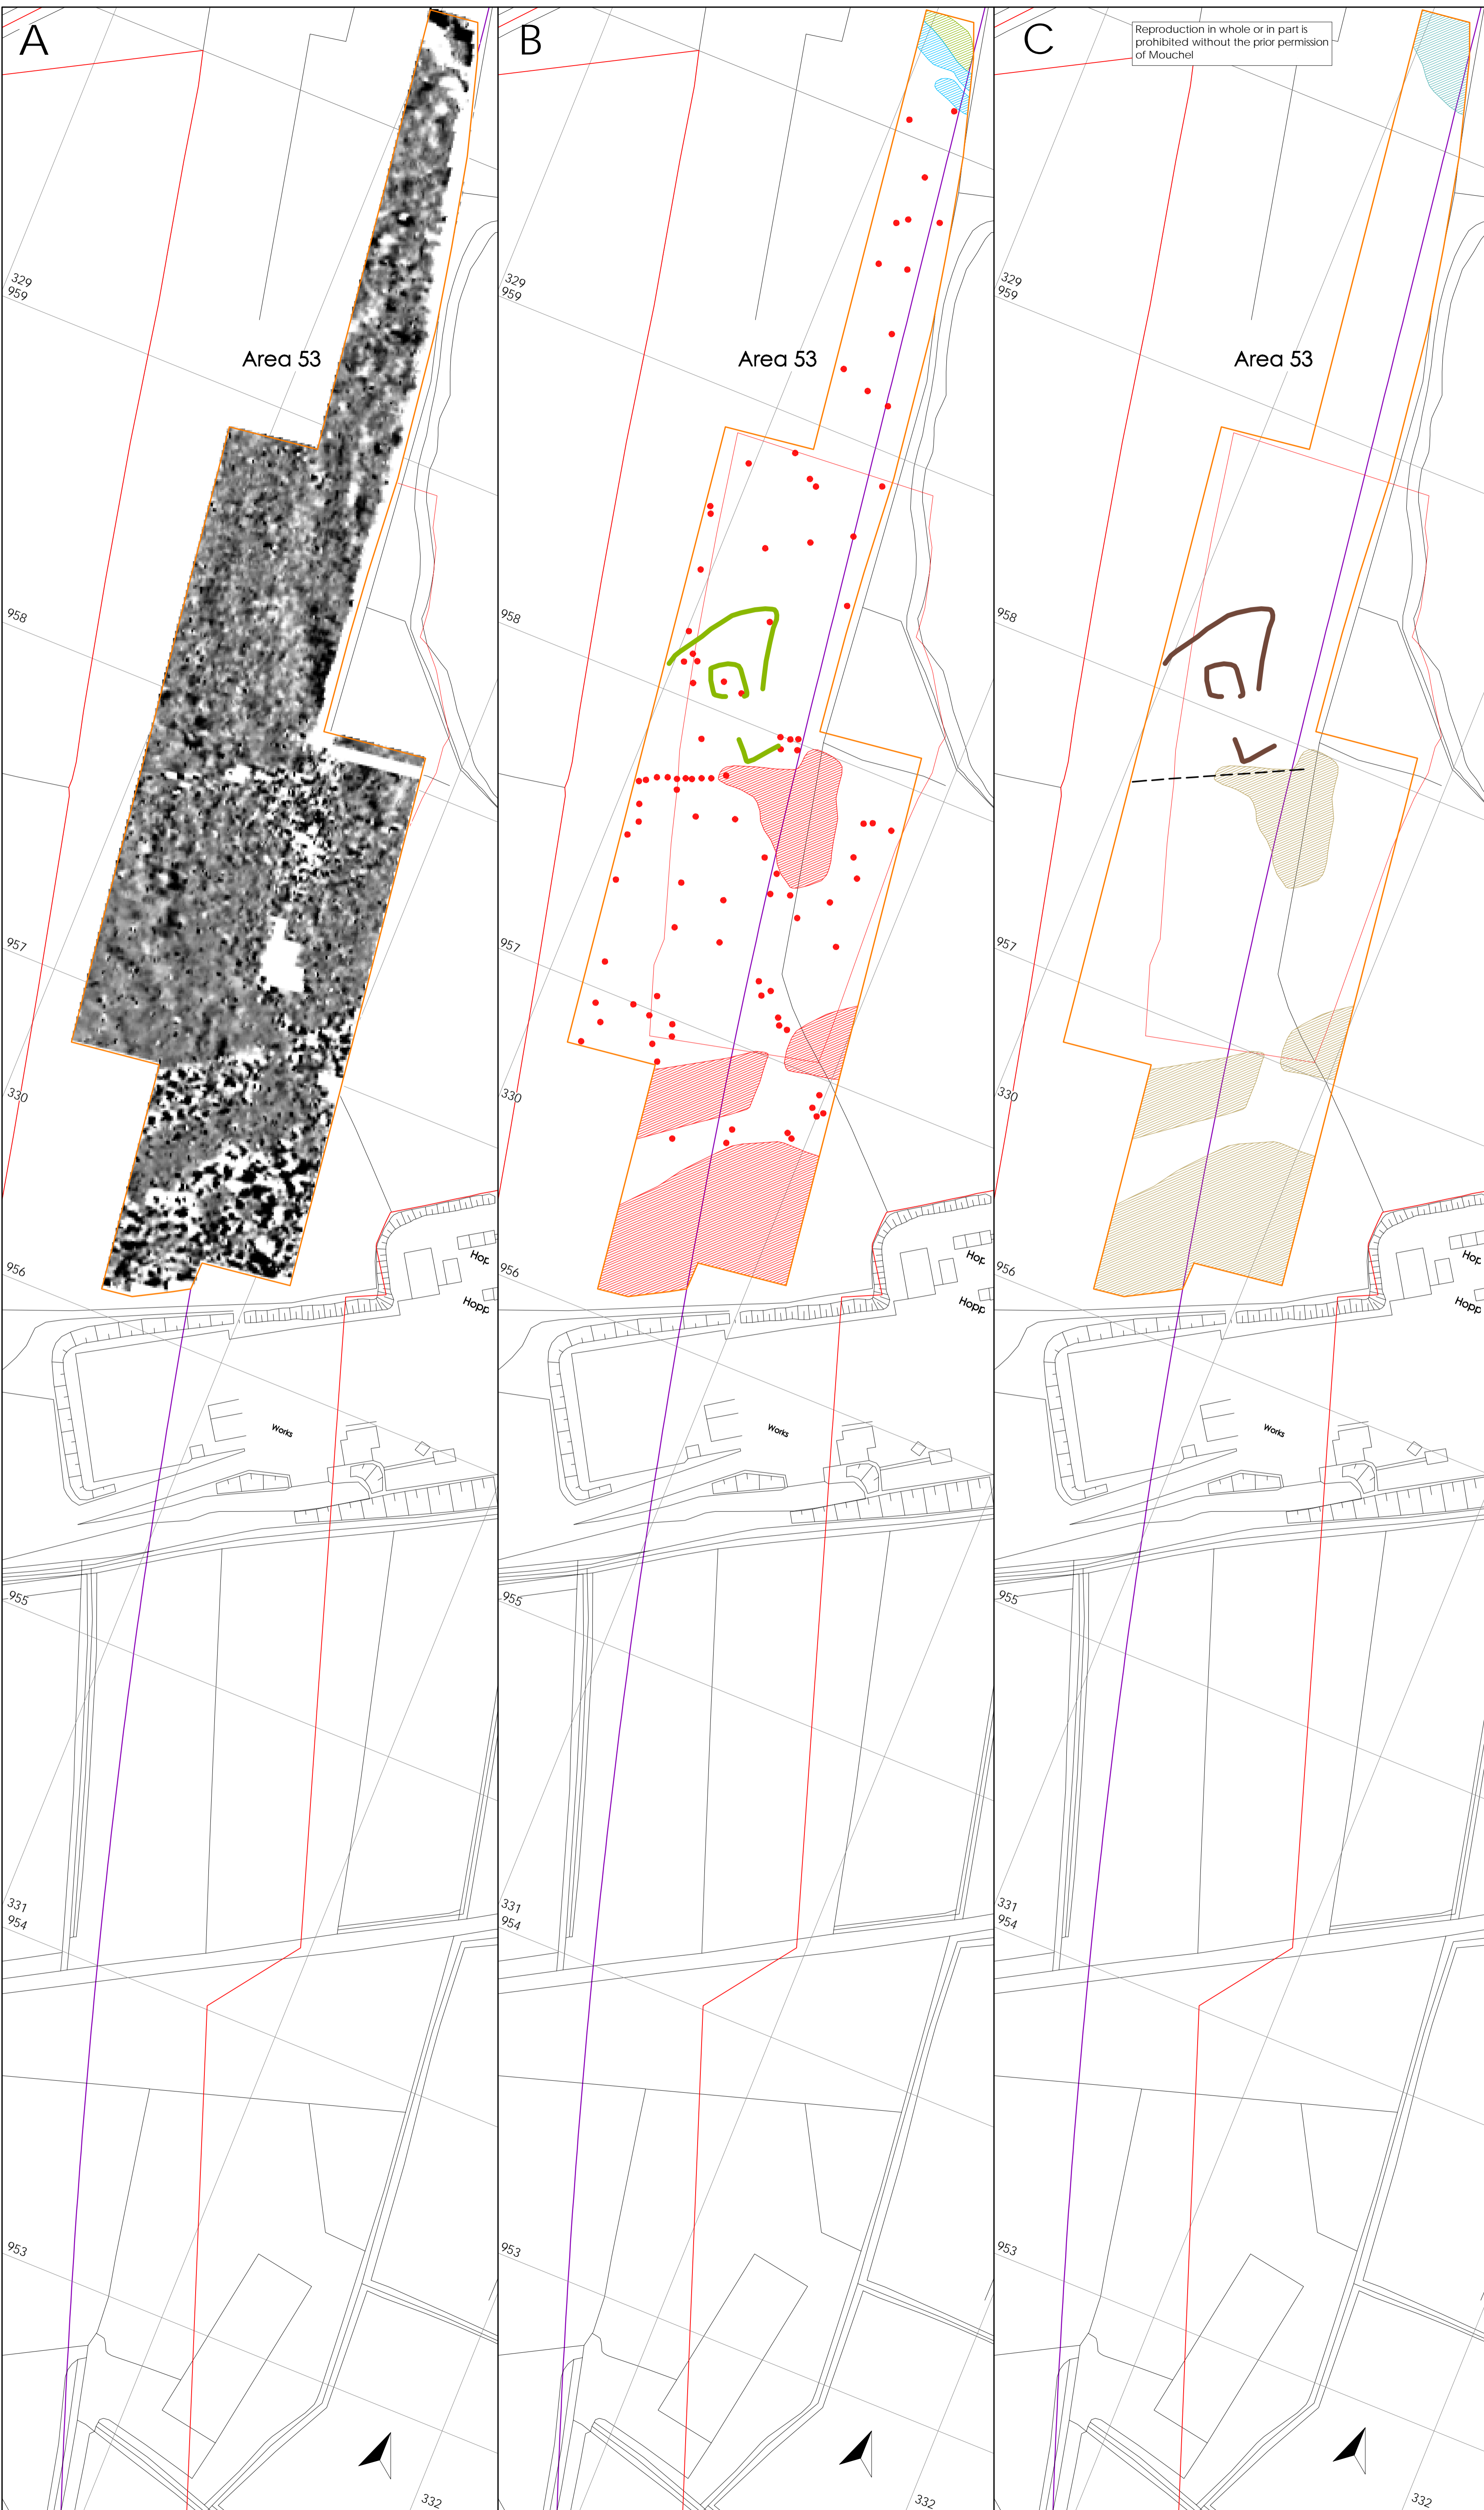
Figure 5: Area 53 geophysical survey and interpretations

- 6.16 Two larger areas of survey were required at previously identified areas of archaeological potential. The more southerly (Area 53; Figure 5) comprised a sub-rectangular enclosure noted on aerial photographs, north of concrete works on the south-western side of Strabane. Parts of the survey area contain a lot of magnetic noise, almost certainly near-surface ferrous and fired debris, however, several possible soil-filled features have been tentatively identified in the central part of the area. The anomalies are all insubstantial but could reflect former gullies or small ditches.
