Section 3
A5 Western Transport Corridor
Northern Ireland

geophysical survey

report 2746, volume I
January 2012

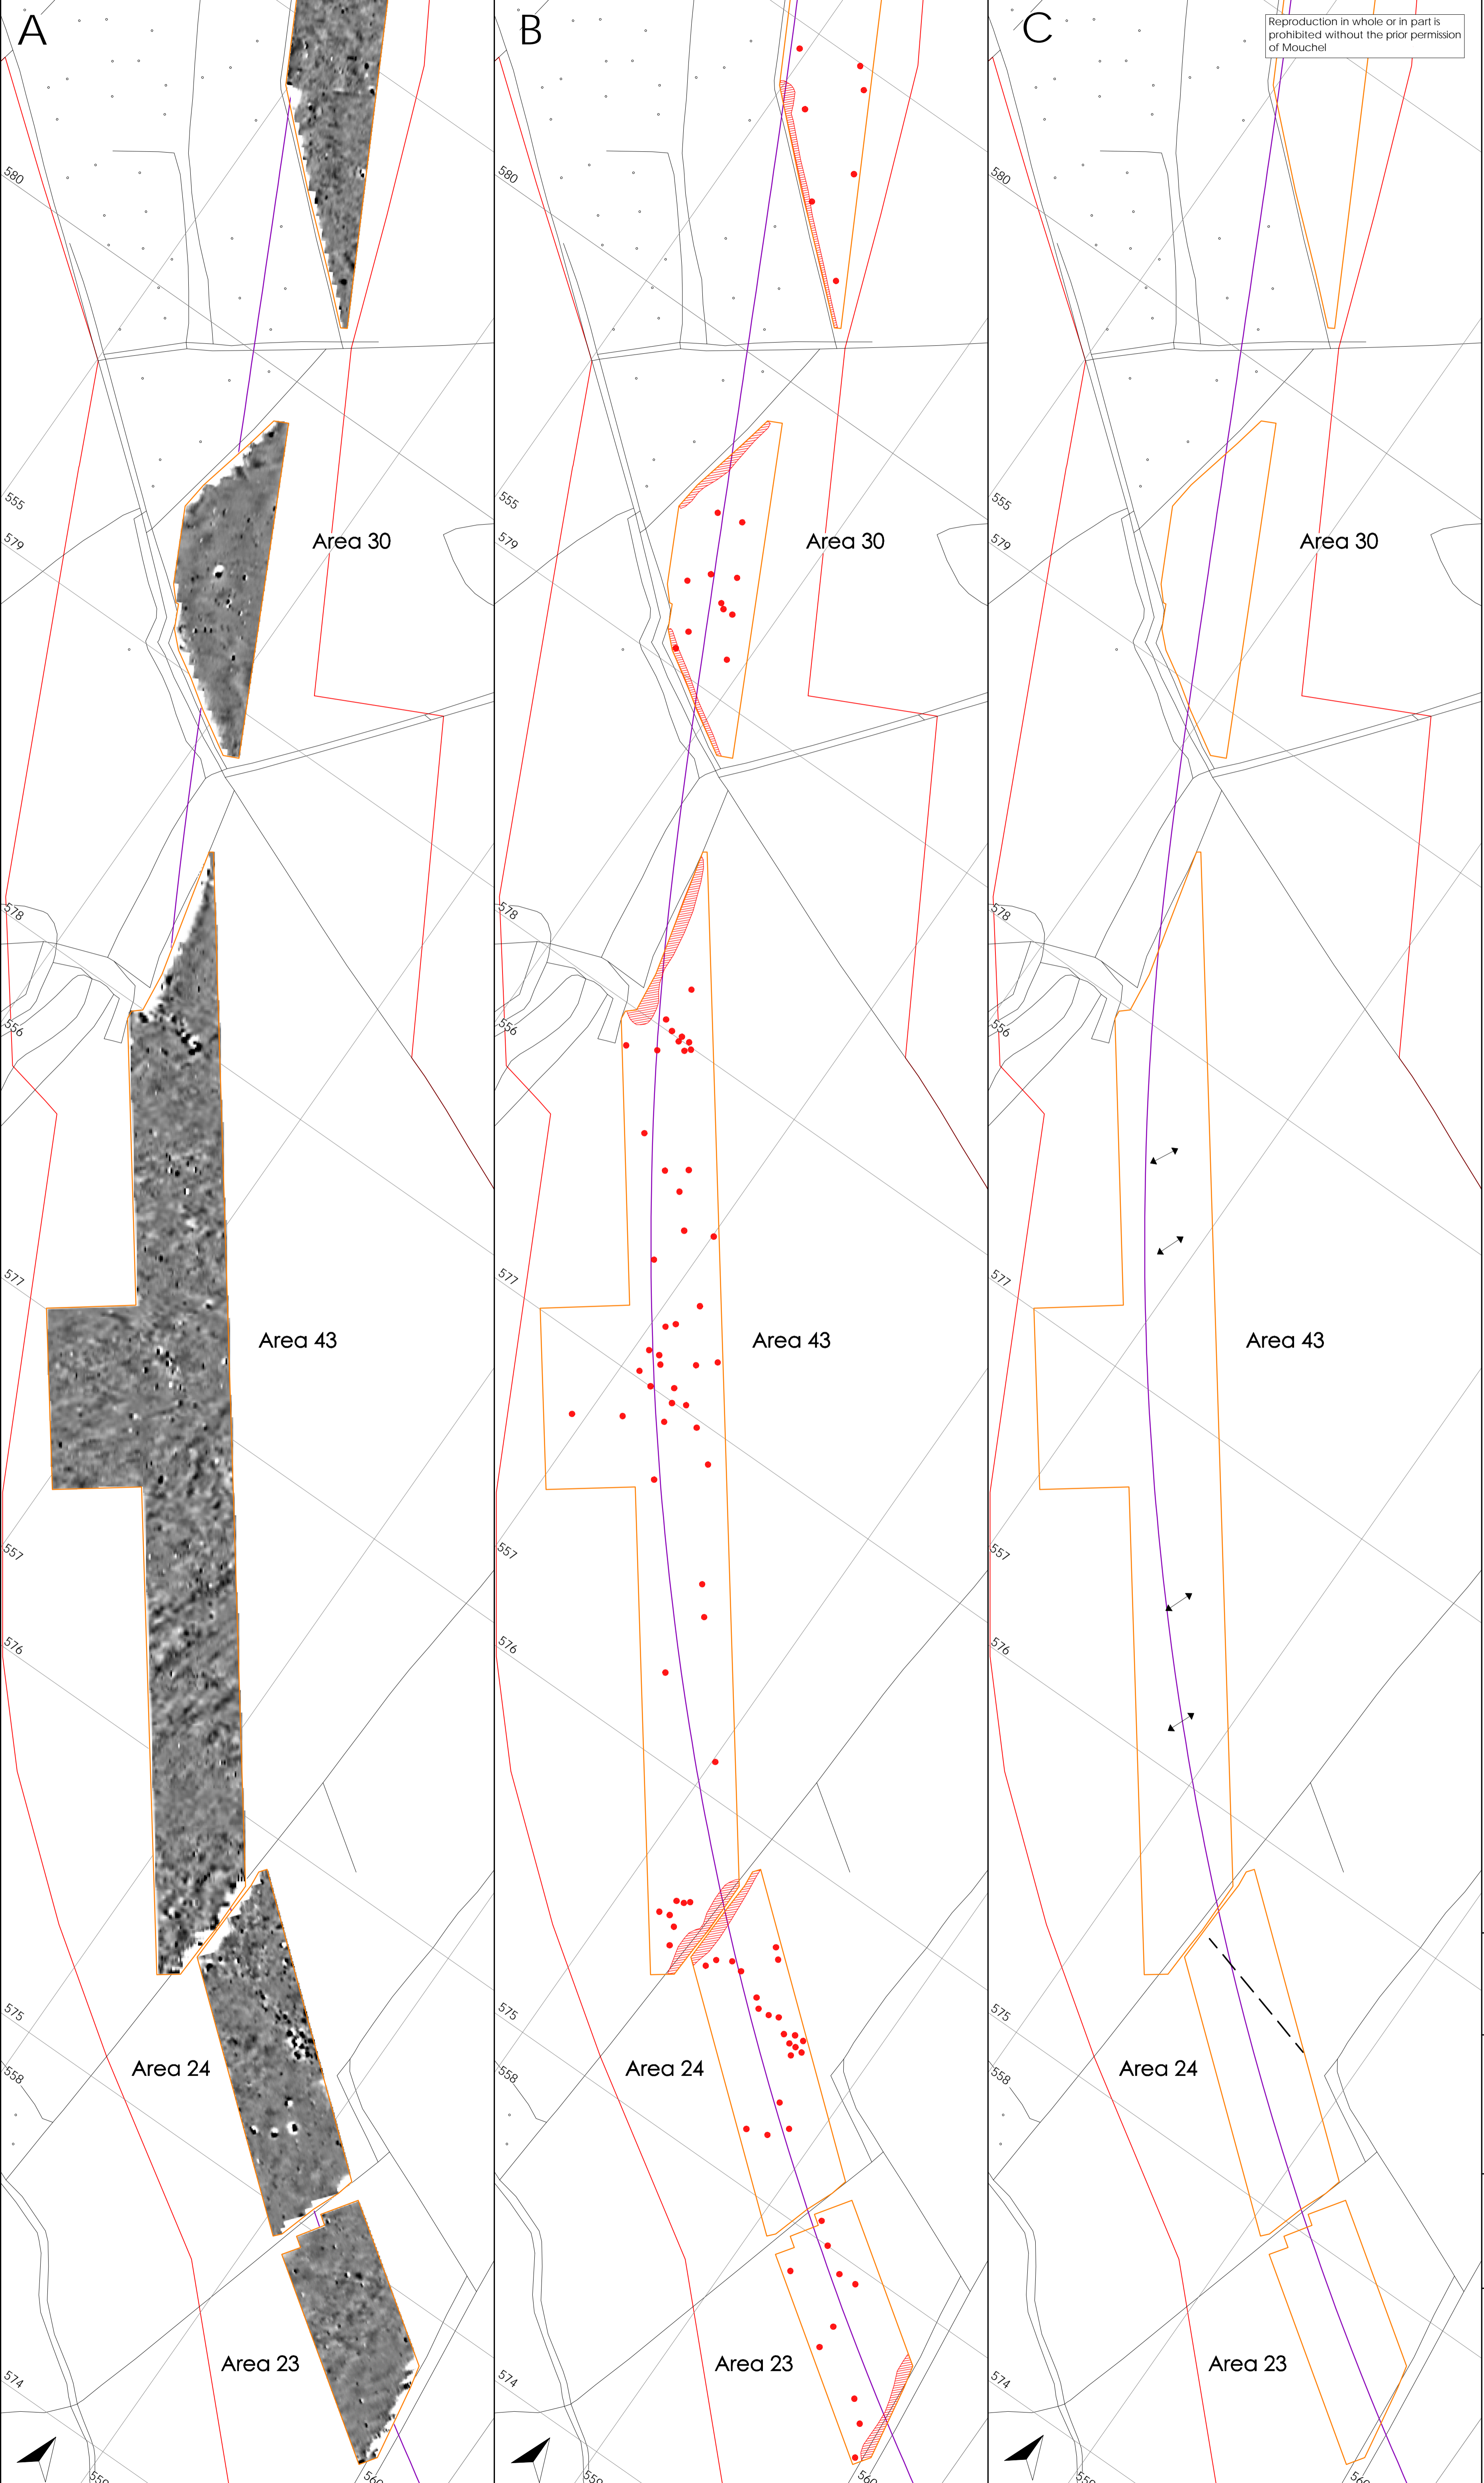
Figure 11: Areas 21 and 22 geophysical survey and interpretations

- A - geophysical survey
- magnetic survey
 - road centreline
 - vesting line
- B - geophysical interpretation
- dipolar magnetic anomaly
 - positive magnetic anomaly
- C - archaeological interpretation
- former plough
 - former field boundary

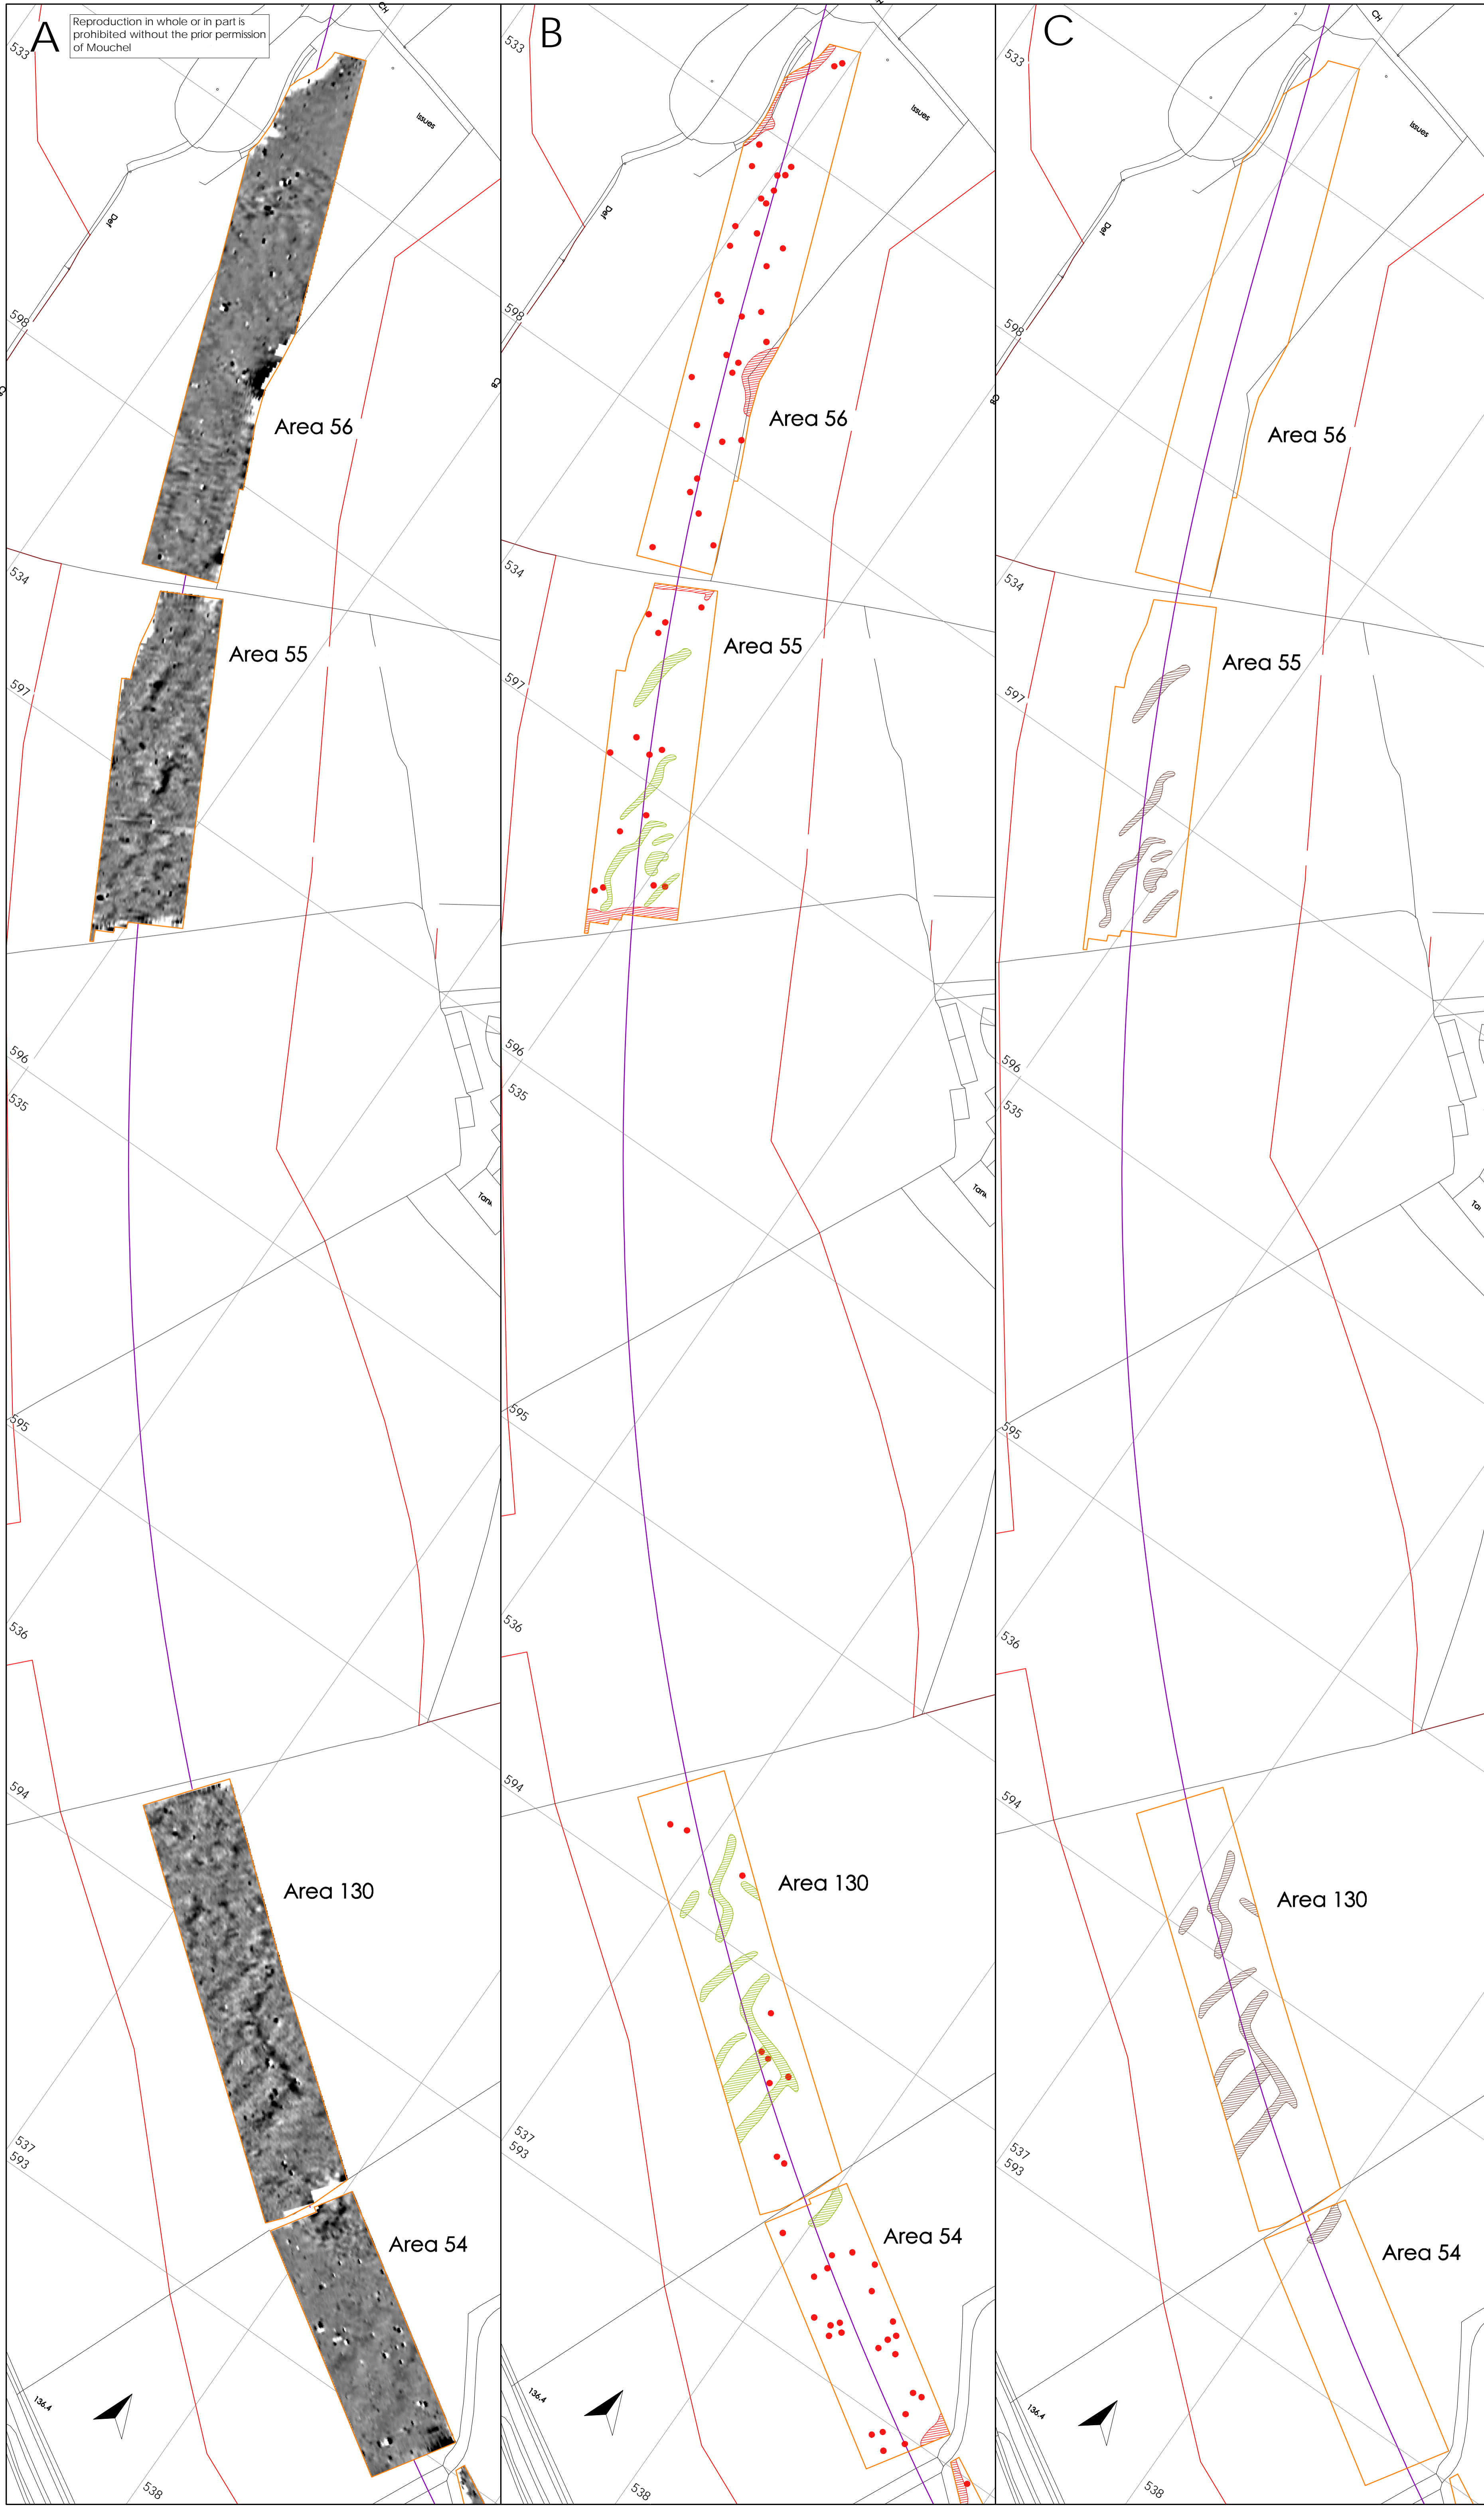
Figure 15: Areas 32, 33, 34, 35 and 53
geophysical survey and interpretations

- A - geophysical survey
 - magnetic survey
 - road centreline
 - vesting line
- B - geophysical interpretation
 - dipolar magnetic anomaly
 - positive magnetic anomaly
- C - archaeological interpretation
 - soil-filled feature

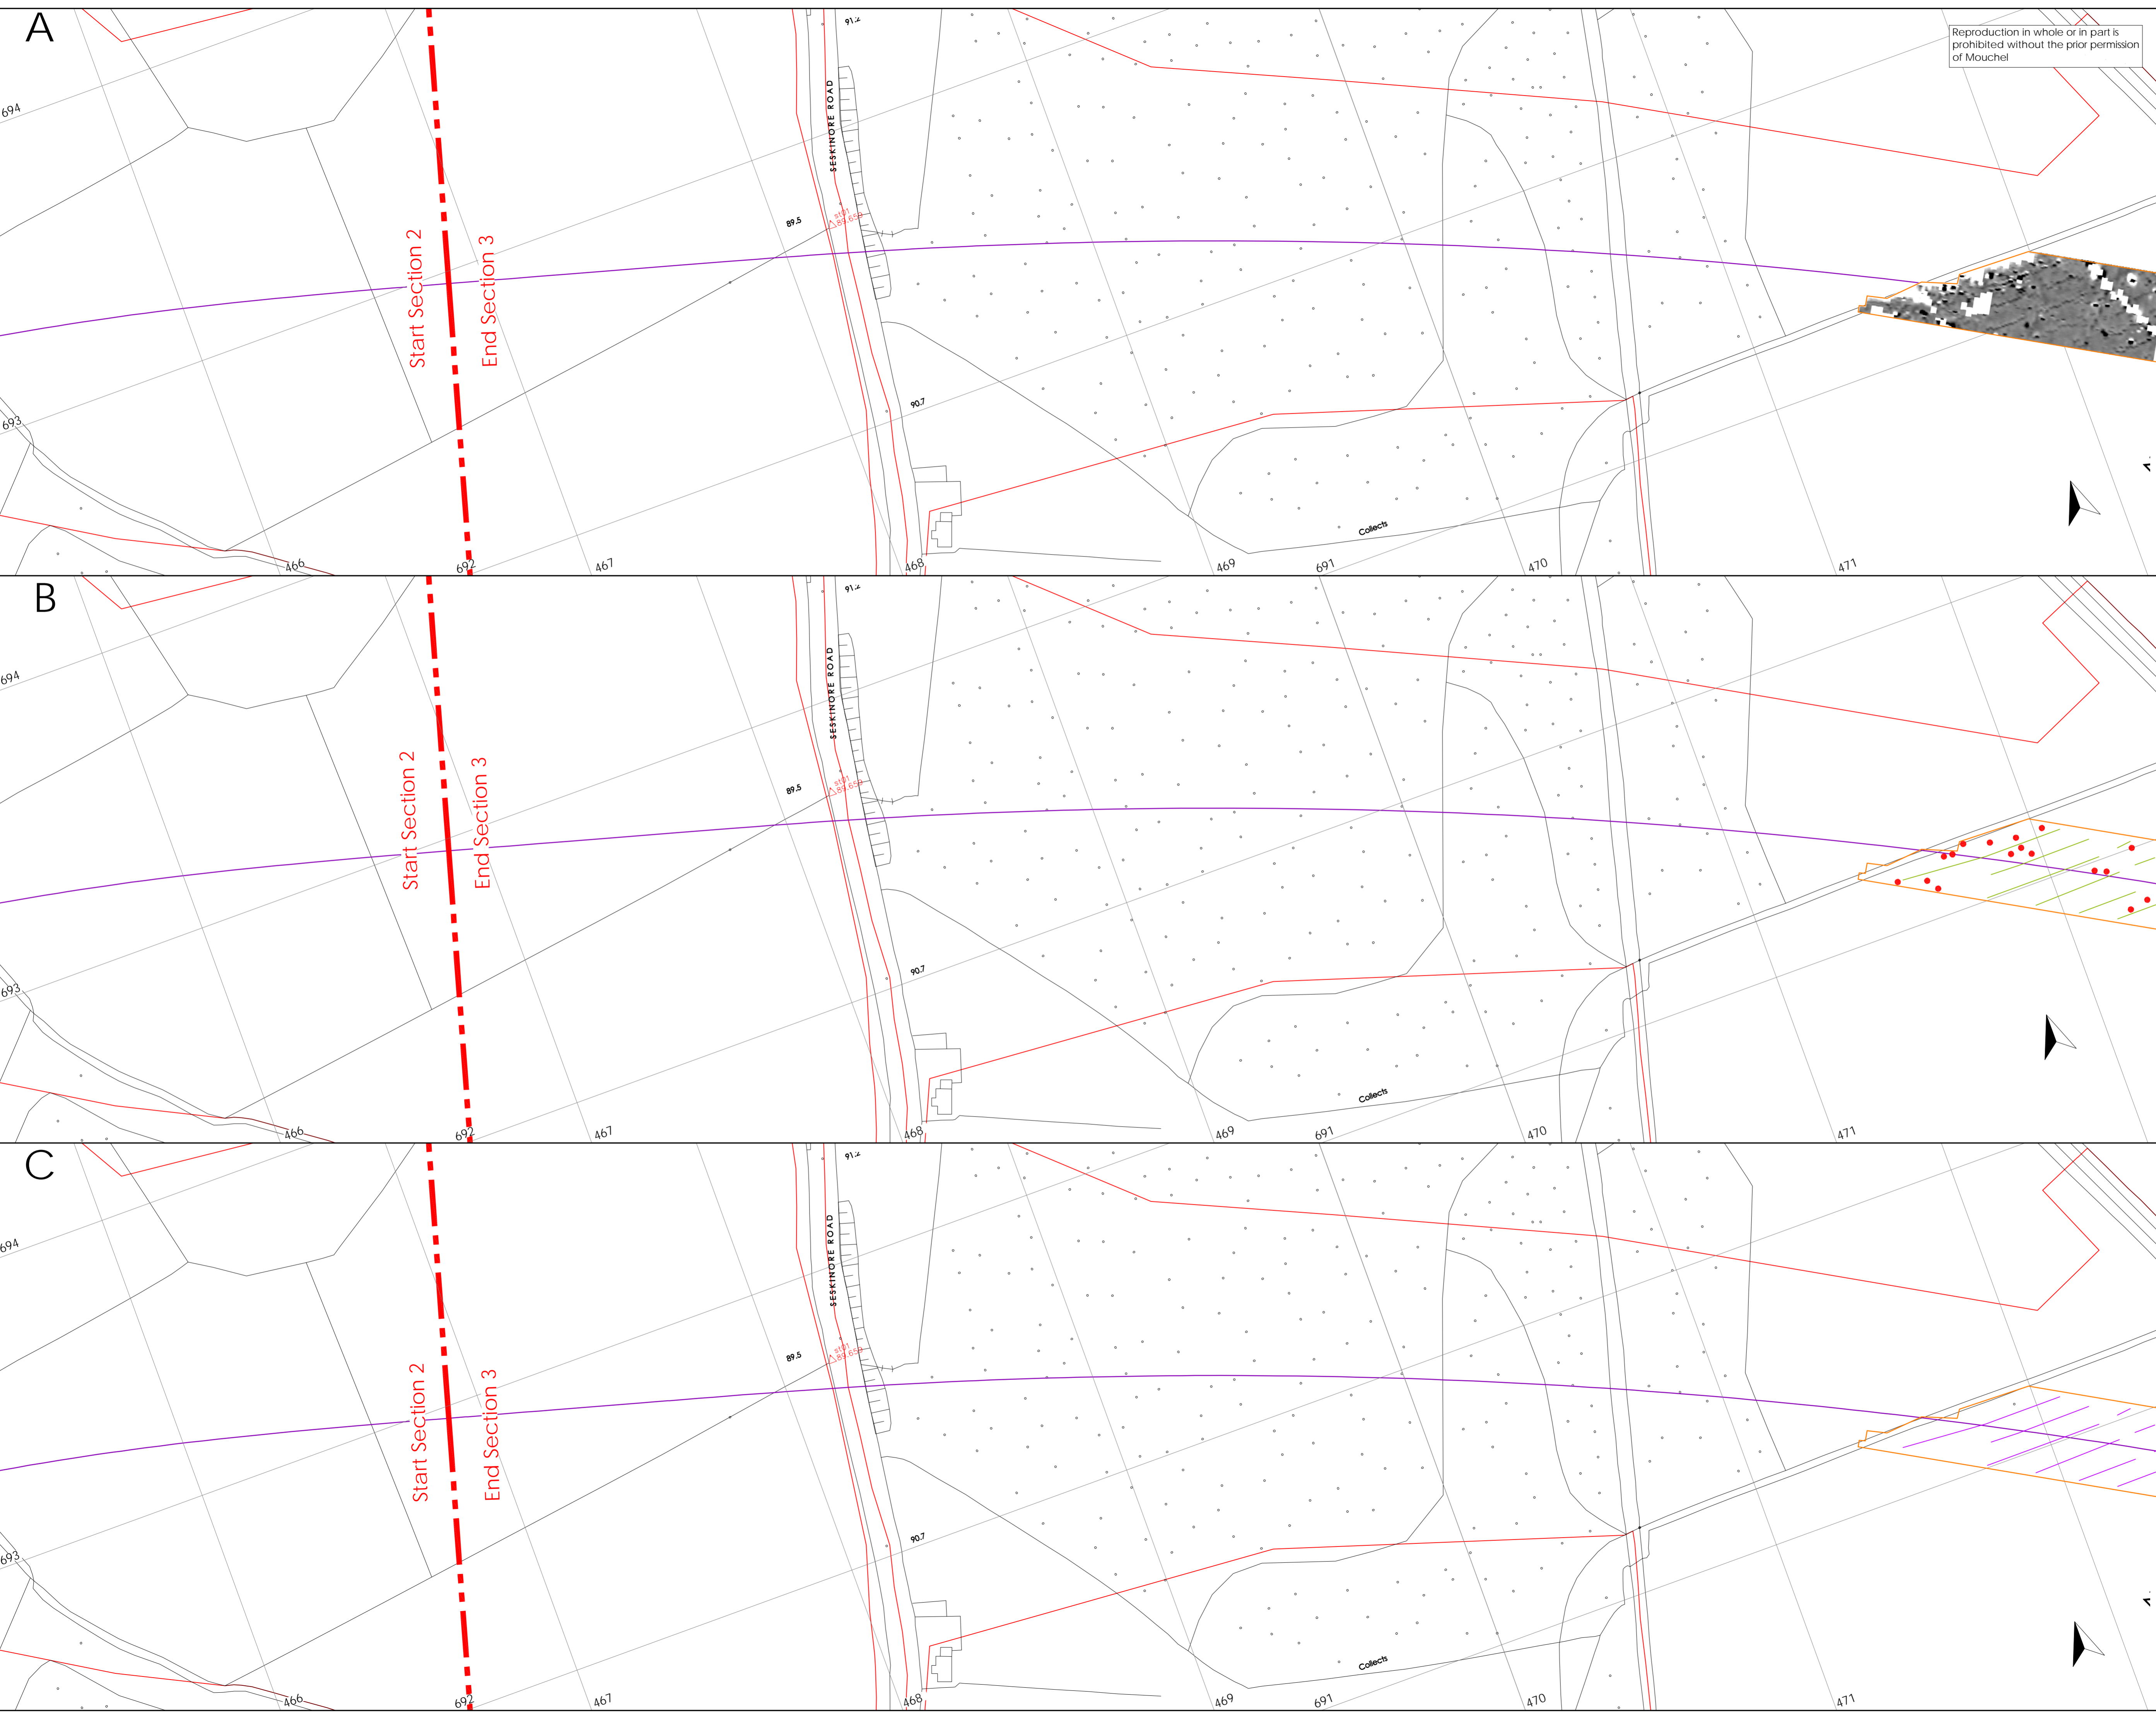
Figure 31: Areas 126, 127 and 128
geophysical survey and interpretations

- A - geophysical survey
 - magnetic survey
 - road centreline
 - vesting line
- B - geophysical interpretation
 - dipolar magnetic anomaly
 - positive magnetic anomaly
- C - archaeological interpretation
 - land drain
