ARCHAEOLOGICAL SURVEY OF NORTHERN IRELAND

EXCAVATION AT BRIGAL KEEROGUE.

Commentary on Conservation Work, Errigal Kierogue, Co. Tyrone.

ERRIGAL KEEBOGUE CHURCH. SM 74R 59:6.

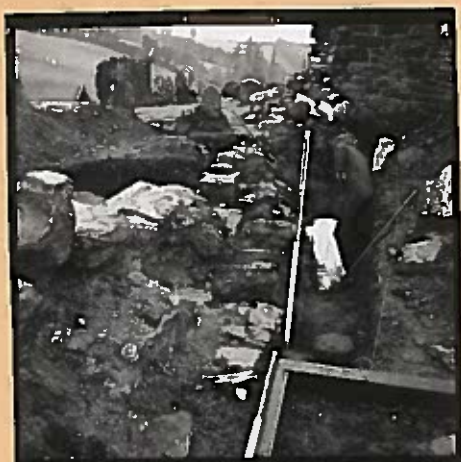
← surviving footings

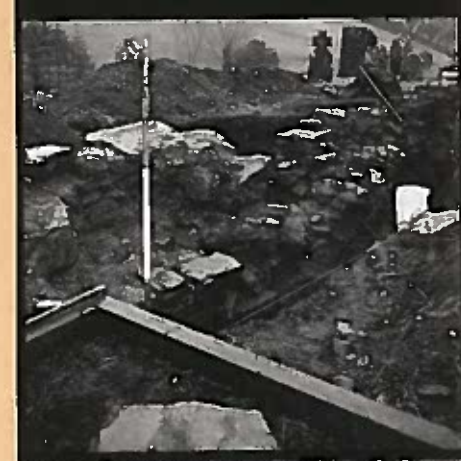
← surviving footings

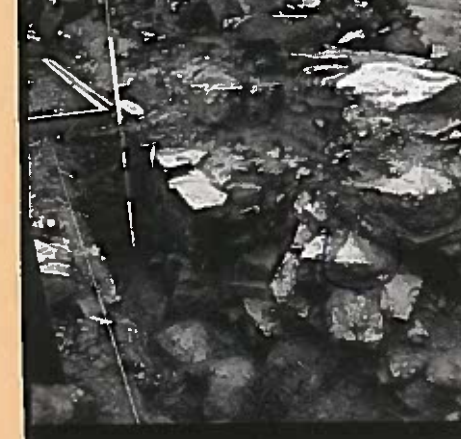
← surviving footings
as face. This
'corner' angle should
be approximately where
wall would have been S.
had there been
evidence for an
earlier E. gable

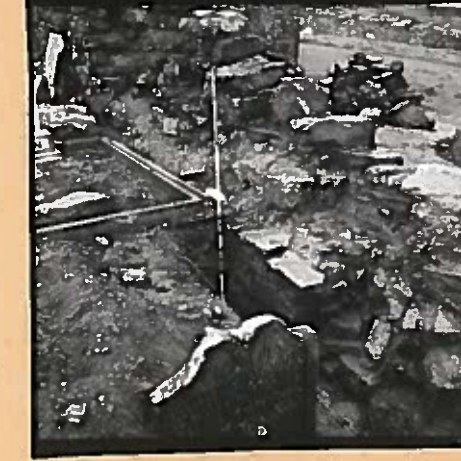
← note quern stone
EK 33

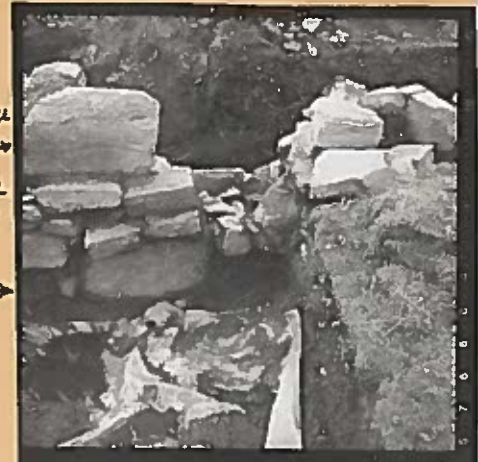
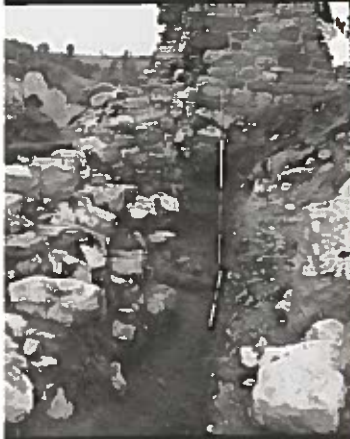
OUTER
late wall face →
late wall footings →
earlier wall face →

group showing N. wall & church. Facing and footings survive on outside (N.) face, inner face largely destroyed by burial disturbance. Subsequent conservation line for inner face taken by joining corner to surviving facing material

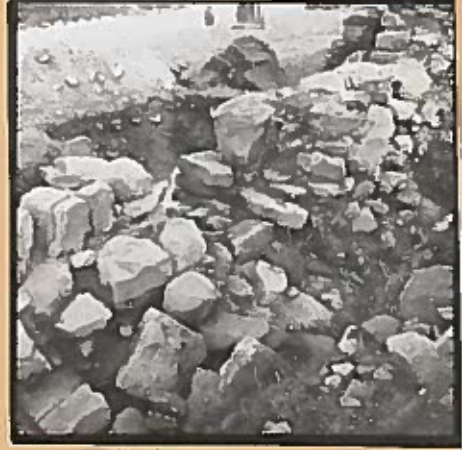
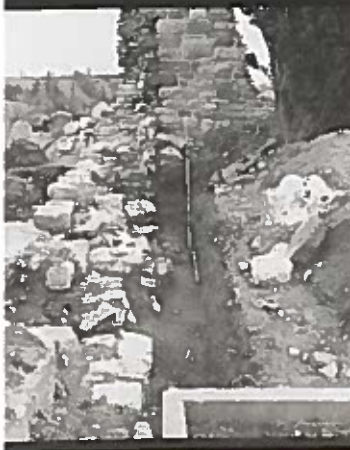
← surviving inner face at corner

← surviving footings

removal of section of wall to establish build and relation to footings was halted when an earlier wall was located beneath the N. wall. Footings of late wall rest upon it

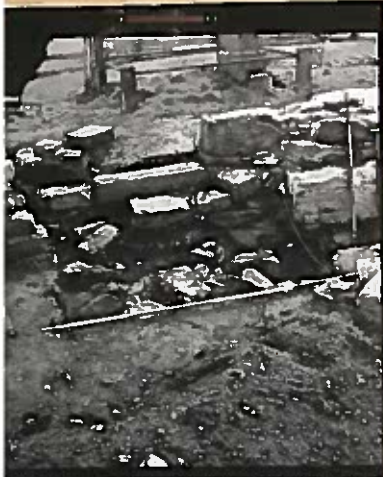
note steps down into church, evident lack of mortar beneath kerb stones. Lack of formal door arrangement as seen in wall finish

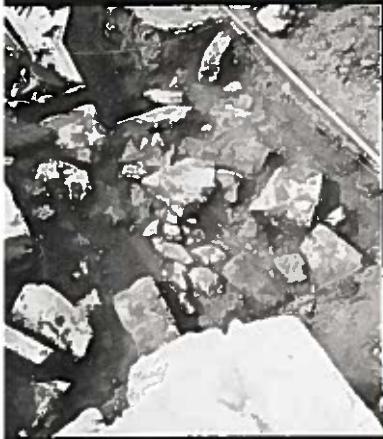
'collapse' of stone inside S. door. Little or no mortar traces. From E.

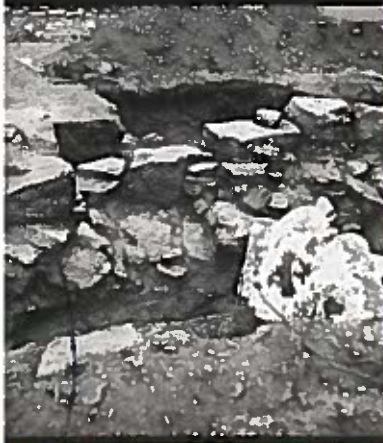
This photo shows N. door from inside with hollow revealed in exact area of door passage. No apparent significance to this.

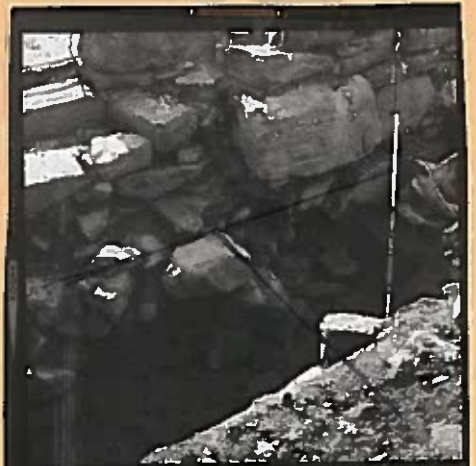
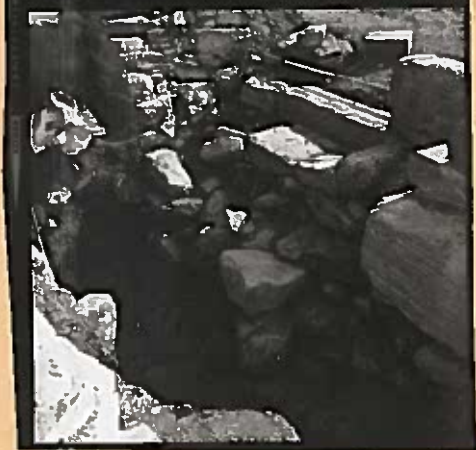
Poor photos. The three stone which give a 'suggestion' of a E. gable are not very clear. They consist of one upper stone and two lower stones with an apparent axis of 90° to S. wall

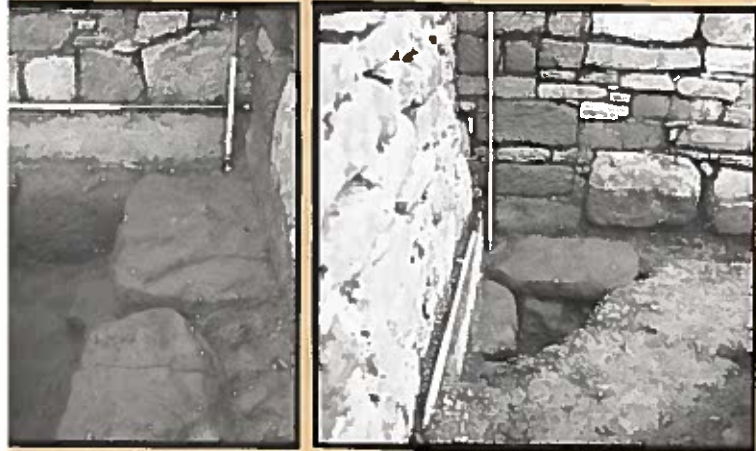
Trench IX inside W. gable

note concrete plank, inserted in this case beneath original facing.

Refacing of the W gable, central section interior face, gave the impression of a blocked W door. Excavations within the church noted that slippage of footings beneath this area (caused by burial) had weakened facing support. There was no evidence (change in footings, worked stone, density of occupation material) to indicate a W door. No work was done outside the W gable.

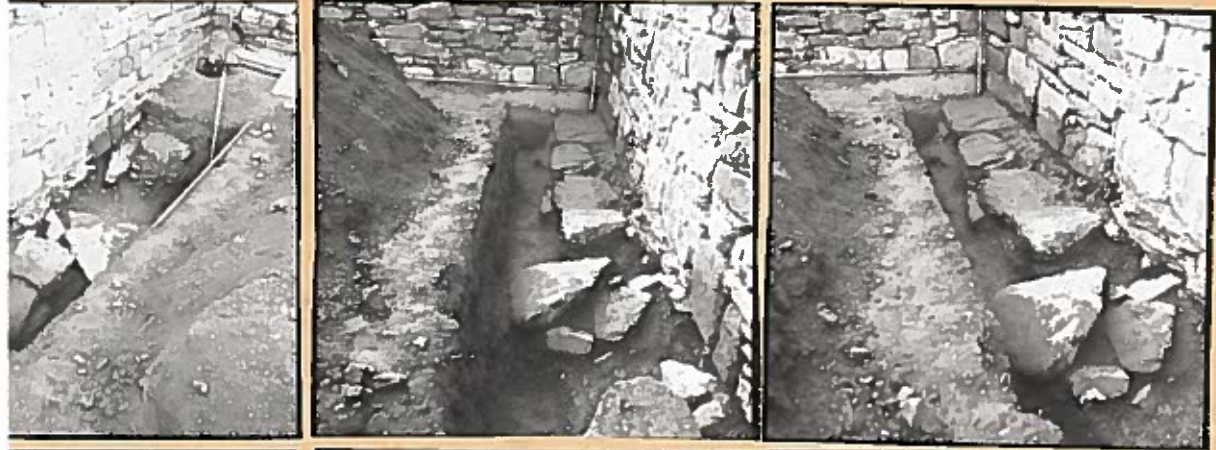
slippage of foerings caused by burial, sections facing - repointed giving artificial appearance of W. door

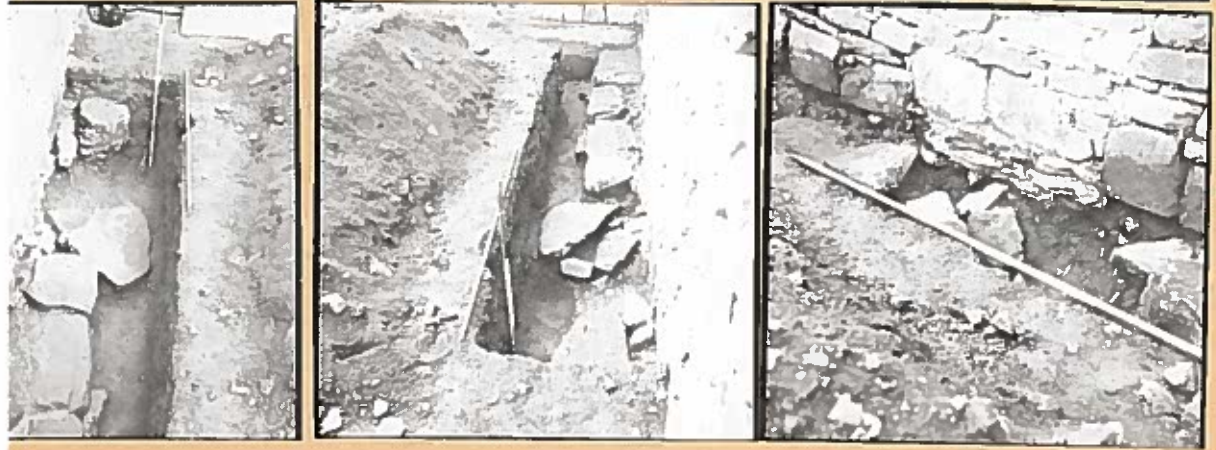
- note insertion of modern concrete where facing replaced

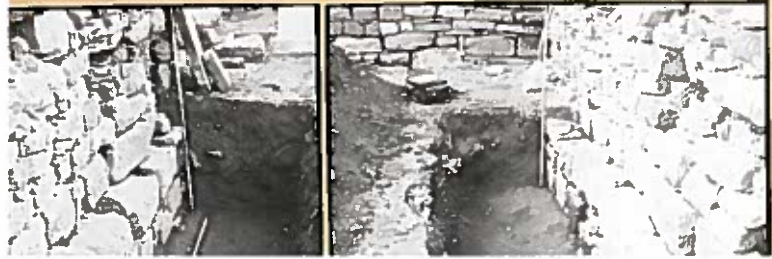
TR. VII very fine foerings

Footings and base of wall very neat, coursing and regular stone sizes. W. end of footings have 3 courses, and E. end still three courses but middle one is very narrow. The stones are all face set, though the upper course has a group of 4 stones edge set though still providing a very neat face. Footings sit neatly on pink clay subsoil (~~not~~ note A.H.'s comment about wall above being fire-reddened). Random footing stones 47 x 30 x 17 cm. Small stones occasionally inserted into chinks.

Otherwise joints always good. Grave soil commences 20 cm. out from face at subsoil level. Stone used only rarely sandstone, mostly roughly shaped conglomerates and perhaps petrological (viz basalt?).

N. wall, W. $\frac{1}{2}$.

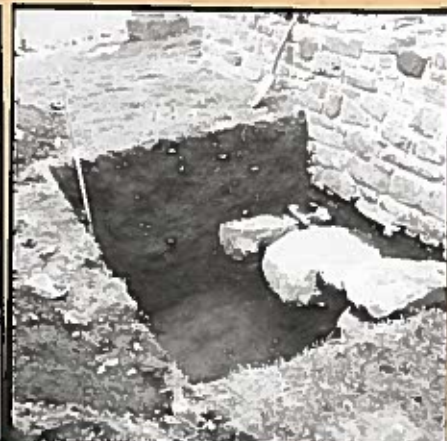
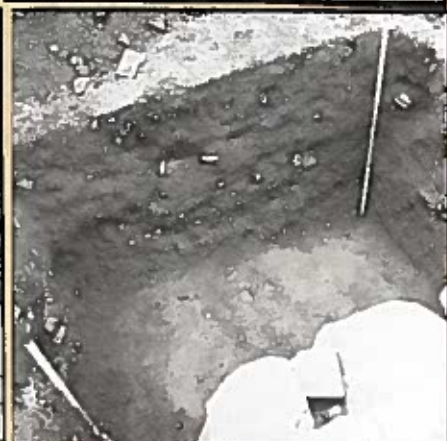
Tr. IV

Footings lie beneath a gap of 14 cm (max) from base of wall to footings; this comprises soil + loose stones jammed in. Footings edges do not lie under wall to a great extent - with the large flat stone the overlap is only four cm. Cannot be said to act as support for church gable. In NW corner of trench is an increase in stone quantity (see photo) beneath main wall.

'Footings' - note gap between stones and base of wall - this is not a modern repointing feature.

Note spread of stone at into trench. Collapse?

Removal of pile of stones reveals soils levels of c. 20cm continued to contain human bones. Onto subsoil.

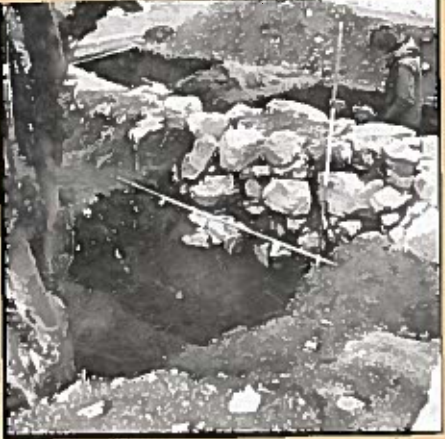
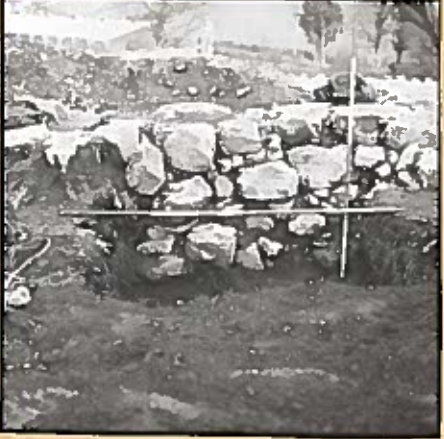
TR. V

note absence
of facing
material

inside N. wall
E. end.
