TC 40/12 Volume 4.

From: [REDACTED]
Sent: 30 January 2015 16:43
To: [REDACTED]
Cc: [REDACTED]
Subject: Site visit - Curraghinalt 30/1/2015

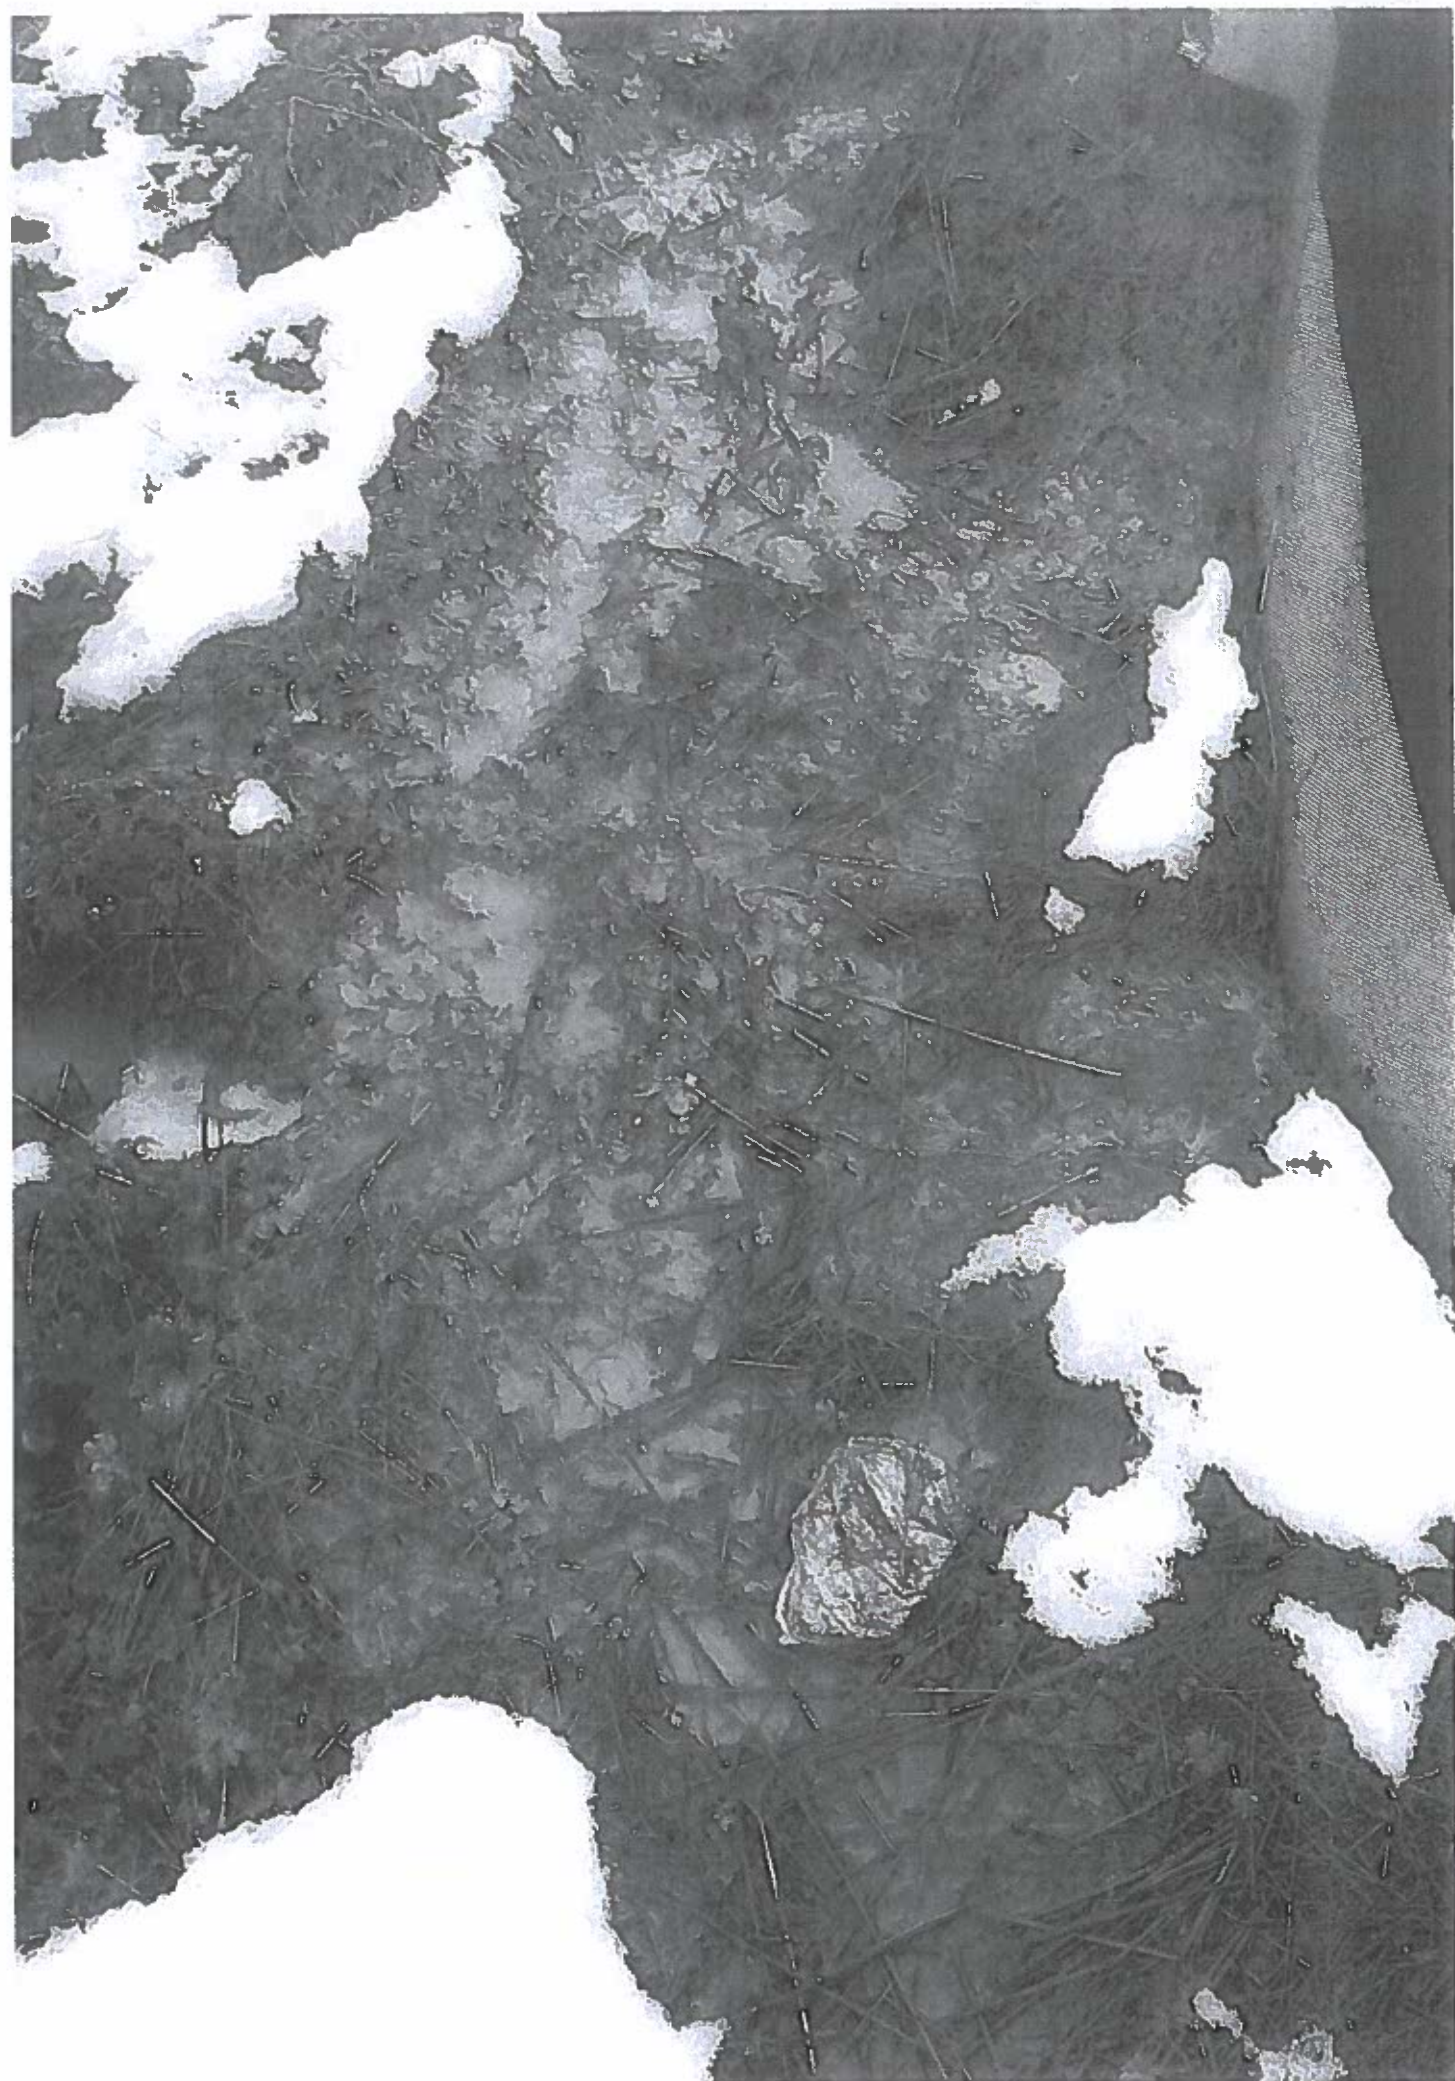
[REDACTED]
I visited the site this afternoon and there was a discharge of site run-off. Water was escaping under the silt fence adjacent to the gate at the bottom of the fence. The discharge was slightly discoloured and it was entering the Curraghinalt Burn. Due to the high flow in the burn there was no visible impact. I made [REDACTED] aware of the issue and he tasked [REDACTED] with getting it resolved.
